IN SITU GROUND EVALUATION BY DEEP SOIL MIXING

A thesis submitted in partial fulfilment of the requirements for the Degree

of Master of Science in Engineering Geology

at the University of Canterbury

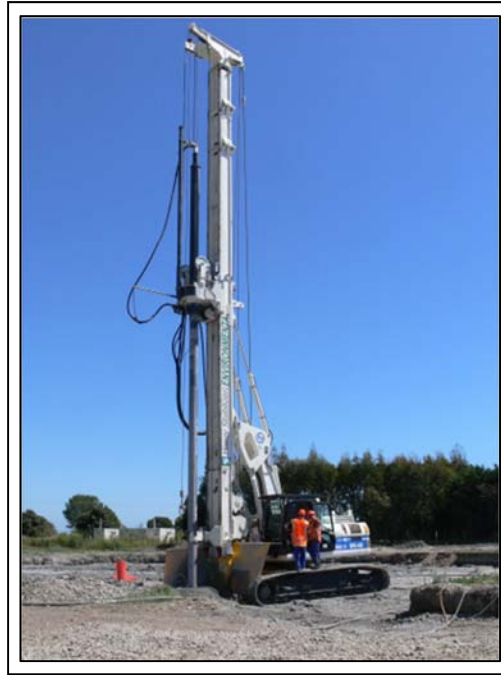
The columns are installed by using a combination of mechanical mixing and high pressure injection (jet grouting) of a cement lime slurry binder. Binders can be introduced to the *in situ* soil either in a wet (slurry) form or dry form. This research is focused on the wet mixing method installed using a TurboJet Rig (Figure 2-1) common to Hiway Geotechnical (NZ) Limited.

Figure 2-1 - Deep Soil Mixing TurboJet Rig (Quickfall, 2010)

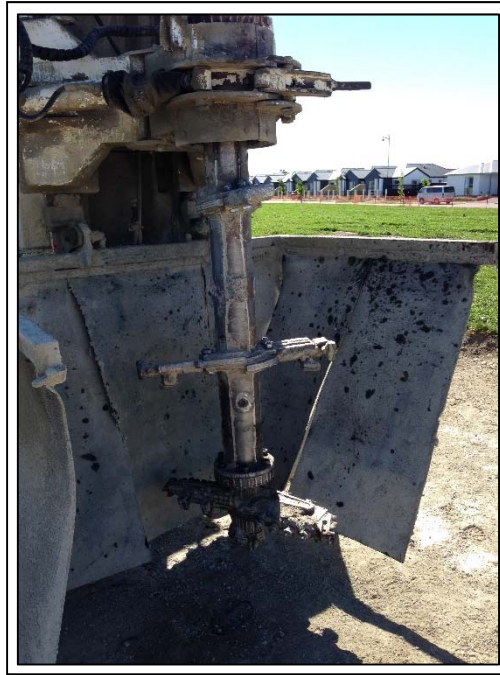
Binder is injected using pressurized air to transport the slurry through the hollow mixing shaft, down to the mixing head, and forced out of multiple nozzles (of a preselected size) under high pressure. The pressure of the injected grout is high enough to cause disaggregation of the soils and create a homogeneous soilcrete mixture, but not substantial enough to induce grout migration outside of the defined column width.

Figure 2-2 - Deep Soil Mixing Head (Hiway Geotechnical NZ Limited, 2015)

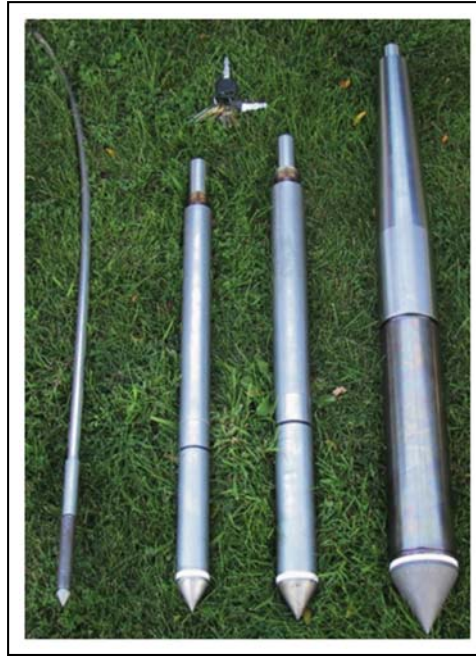
However, this test method is limited where it cannot be used in high density soils, for example, sites with very dense sands or gravels, or site with boulders. Secondly, the sensors on the cone only provide a soil behaviour type (SBT) response, not an absolute soil measurement. So, testing must be accompanied with additional soil testing methods (like a borehole) to provide an accurate representation of the soil profile. Finally, CPT sensors can become contaminated if inadequately prepared prior to testing or the operator error in testing occurs.

Figure 2-6 - Cone Penetrometer Apparatus – 2cm², 10 cm², 15 cm² and 40 cm² (Robertson & Cabal, 2014)

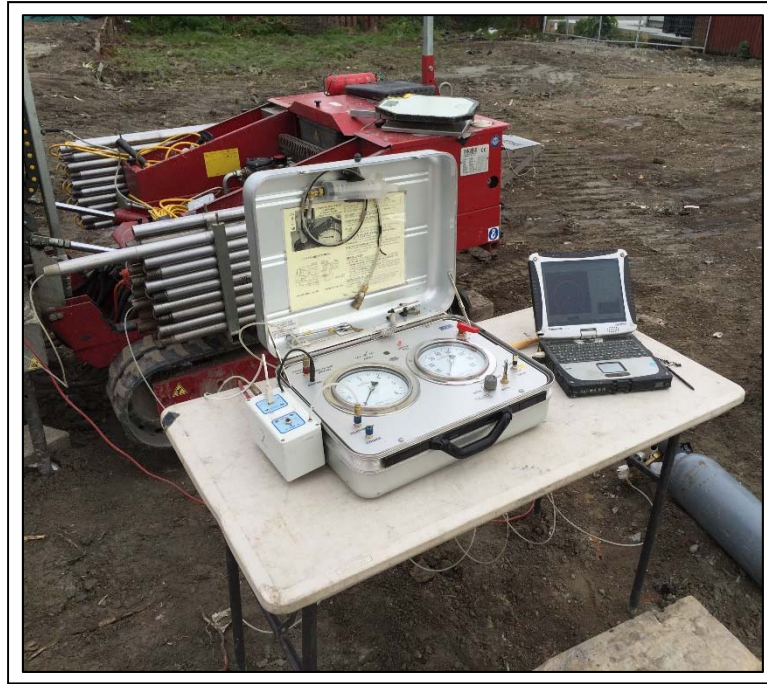
Figure 4-7 - Site Photograph (DMT Testing)

The testing procedure was performed by advancing the DMT blade into the ground and stopping at 0.2 m intervals. At each 0.2 m interval an inflation of the membrane occurs. The initial reading (A-pressure) is made and records how much pressure is required to expand the membrane against the *in situ* soil. Subsequently, the second pressure reading (B-pressure) is taken and records how much pressure is required to advance the centre of the flexible membrane 1.1 mm against the *in situ* soil. An optional reading (C-pressure) can be conducted, which measures the closing pressure after the B pressure reading is recorded. For this research, the A and B pressure readings were completed at 0.2 m intervals, however the C-Pressure was not recorded.

As previously mentioned, DMT testing was completed prior to and following DSM installation to form a comparison of the soil characteristic response to ground improvement. The DMT test is a standardised method which attaches to a hydraulic CPT rig. Therefore, for this research the initial and post DSM testing was conducted using a Pagani TG63-150 1.5t hydraulic rig (Figure 4-4). Like the the CPT testing procedure mentioned above, the rig was augured into the ground to provide resistance as the blade is advanced into the ground (see Appendix G for Rig Factsheet). During testing, auguring into the mixed fill and granular material following demolition proved to be slow and time consuming. However, this testing method was unable to be revised due to a shortage of larger push rigs at the time of this research.

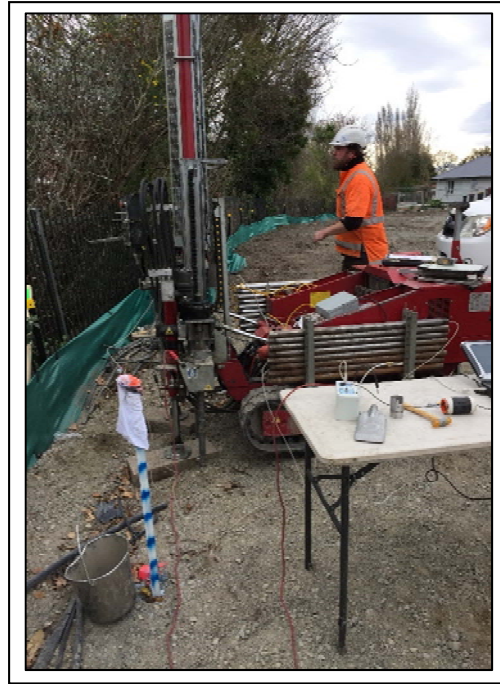
Figure 4-8 - Site Photograph (sDMT Testing)

As the DMT is advanced, the operator stops the blade at 0.5 m intervals within the *in situ* soil. The shear wave source at the surface is a 10 kg pendulum hammer. This is released and strikes a steel plate orientated long axis parallel to the receivers to generate the highest sensitivity wave. The plate is wedged against the soil by the base of the operator’s truck. As the pendulum hammer strikes the steel plate, the waves propagate through the *in situ* soil towards the two receivers in the seismic module. The seismic module records the zero time signal as the hammer impacts the steel plate and subsequently records how long it takes wave to travel through the soil and pass the two receivers (Marchetti, et al., 2001). The wave responses in receiver 1 (S1) and receiver 2 (S2) are re phased together over the difference in time to produce a shear wave velocity reading.

As previously mentioned, testing was completed prior to and following DSM installation. For this research the initial testing was conducted using a Pagani TG63-150 1.5t hydraulic rig (Figure 4-4) where, like the CPT testing procedure mentioned above, the rig is augured into the ground to provide resistance as the blade and seismic module is advanced into the ground (see Appendix G for Rig Factsheet).

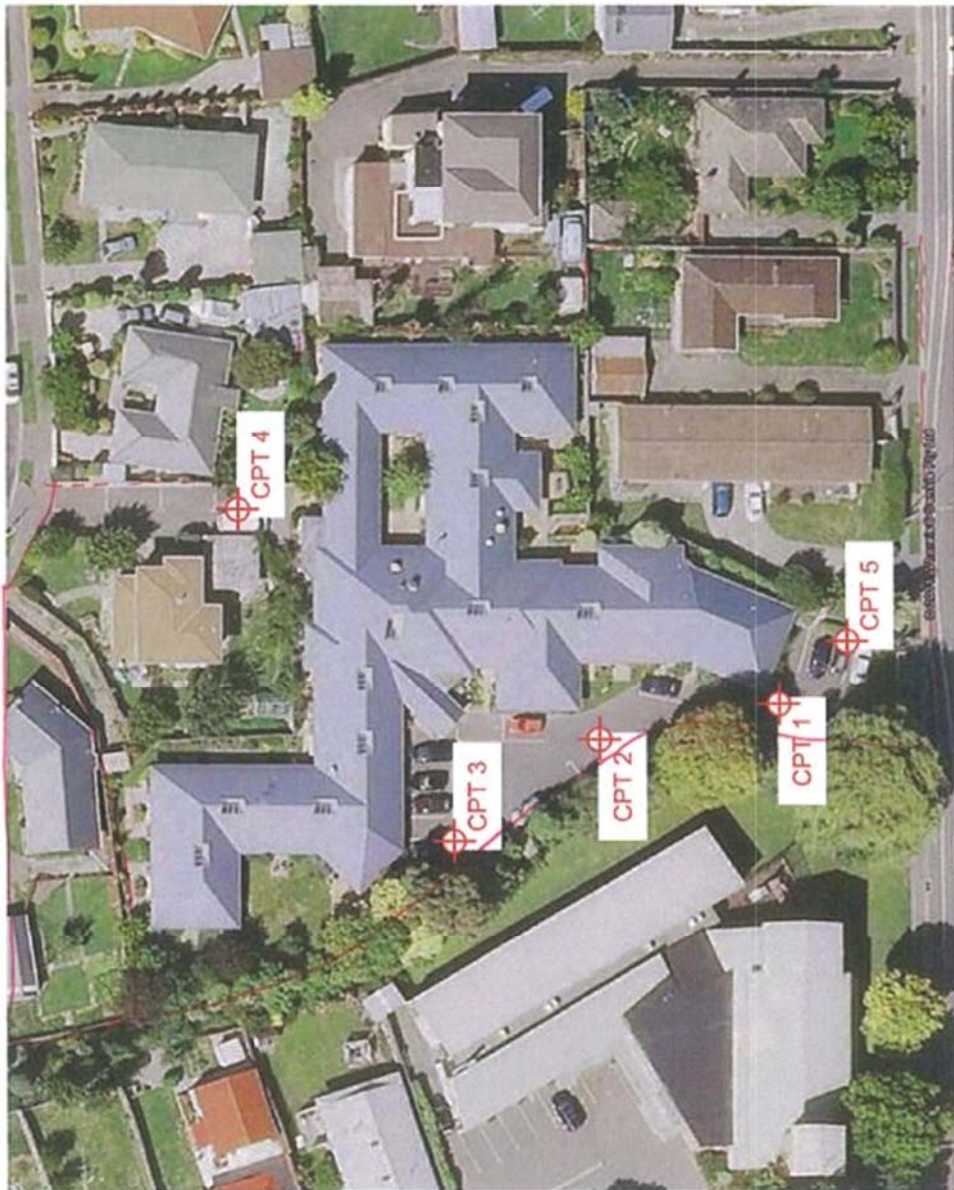
Cone Penetrometer Test

Note: Not to scale; boundaries and locations are approximate only

aurecon Aurecon New Zealand Limited Unit 1 150 Cavendish Road PO Box 1061 Christchurch - New Zealand Telephone: +64 3 366 0821 Facsimile: +64 3 379 6955 Email: christchurch@ap.aurecongroup.com Website: www.aurecongroup.com		Client	Willowlea Senior CareLtd	Figure 3		Paper Size	A4
Project		Willowlea Senior Care		Geotechnical Test Locations		Revision	
By		LFS		Date	October 2011	Job Number	219038-002
						1

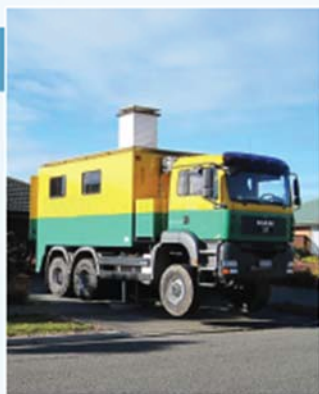
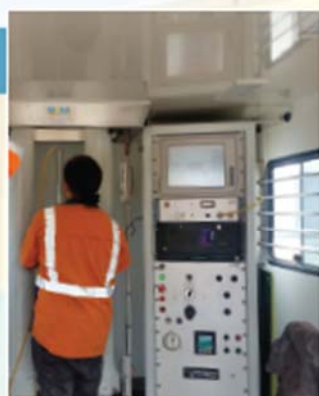
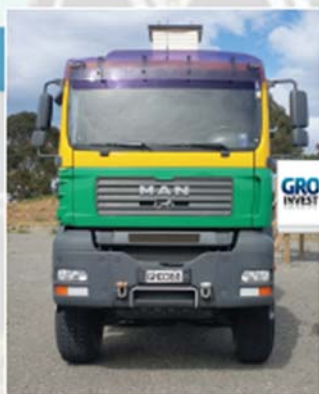
6x6 TRUCK RIG

This CPT truck has been purpose built in the Netherlands by Geomil on a MAN 6 x 6 platform. It has 200 kN push rams with a push/pull clamp.

The truck is levelled using four hydraulically operated feet. It can operate on slopes of up to 15 degrees.

The truck has a weight of 22 tons and has 20 ton push capacity. The following operations can be performed:

- CPT/SCPT Testing
- DMT/SDMT Testing
- Mostap Sampling
- Piezometer Installation

The depth capacity is 60 m+ (depending on ground conditions.)

Height:	3.5 m (top down) 4.4 m (top up)
Length:	7.4 m
Width:	2.5 m
Weight:	22,000 kg

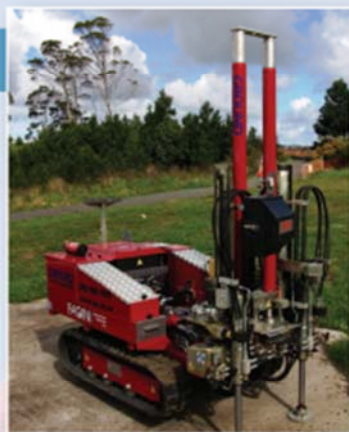
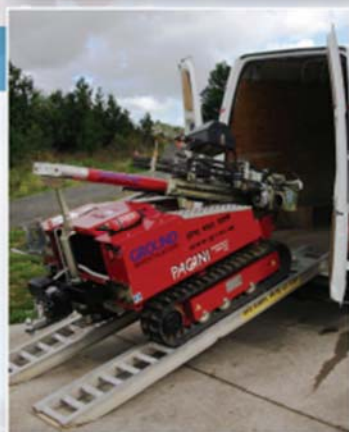
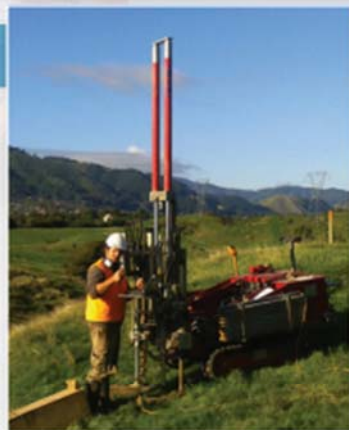
PAGANI CPT RIG

The Pagani TG63-150 is a fully hydraulic rig on rubber tracks which runs on a petrol engine. The compact size and light weight of the rig make it extremely manoeuvrable and able to access difficult sites. The rig is equipped with an automatic self-anchoring system, which quickly anchors the rig to the ground using 100 mm diameter continuous spiral screw anchors or larger diameter single spiral anchors.

The rig is transported to and from site in the back of a transit van or light truck. This makes the rig easy and quick to transport to site with low establishment cost. The light weight of the rig allows it to be easily lifted using a crane, Hiab or helicopter.

With anchorage, the rig is able to push up to 15 tons. The anchors are very effective, giving good anchorage in almost all conditions (including soft clays and loose sands). The rig is also equipped with a drop hammer for dynamic testing and sampling. The drop hammer is a 63.5 kg hammer with a drop height of 750 mm (SPT configuration).

• CPT/SCPT • DMT/SDMT • DPSH

In addition, continuous or targeted sampling can be undertaken with this rig. The maximum depth capacity for in situ testing is 30 m+.

Height:	1.5 m (mast down) 3.8 m (mast up)
Length:	2.3 m
Width:	1.2 m
Weight:	1,100 kg
